## Yellow battery symbol fault message in multifunction display "Start Engine. See Owner's Manual".

Topic number	LI54.10-P-067414
Version	1
Function group	54.10 Battery, power supply, voltage converter
Date	12-04-2017
Validity	Model 205, 253 Model 166, 292
Reason for change	
Reason for block

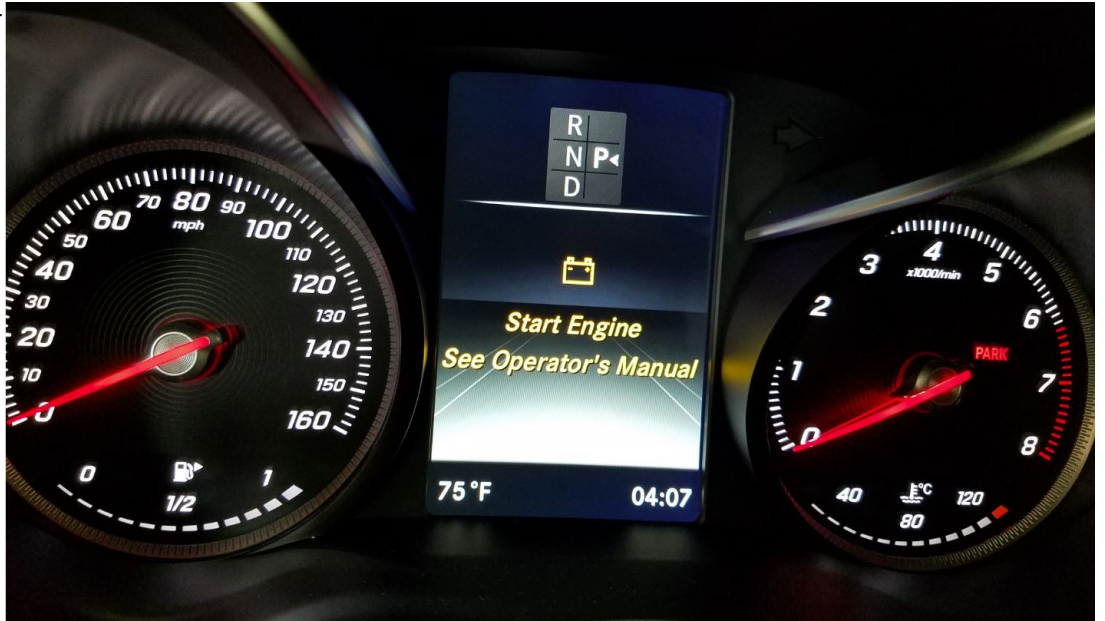
Start Engine. See Operator's Manual.jpg:

Yellow battery symbol fault message in multifunction display "Start Engine. See Owner's Manual".

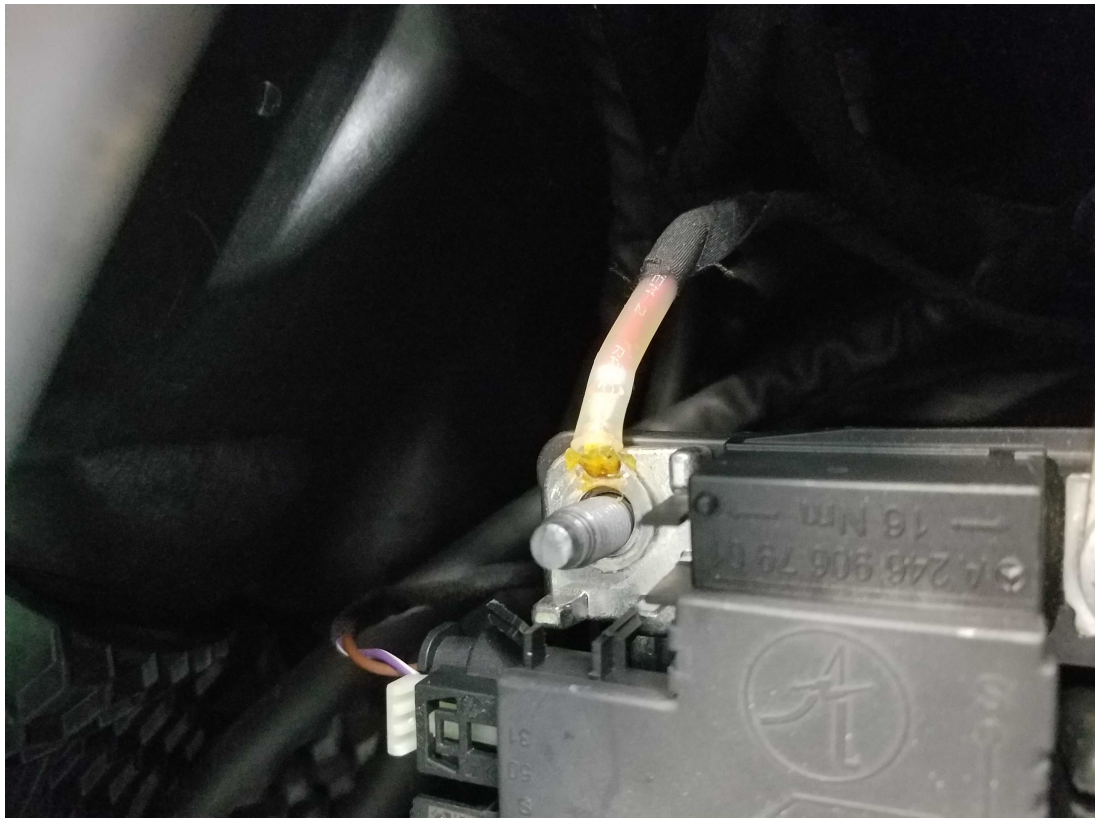
B95 Positive Post Connection on Battery.jpg:

Excess hot melt adhesive from the heat-shrinkable tube on the cable lug of the measurement line (0.75 mm<sup>2</sup>) from the on-board electrical system battery G1 to the battery sensor B95 leads to an increase in the internal resistance R<sub>di</sub> of the battery. Due to the high battery internal resistance, the yellow fault message is generated in the multifunction display at 8 mΩ and above.

Carefully remove the excess hot melt adhesive using a small screwdriver until the contact surface of the cable lug is free of hot melt adhesive residues.

Be careful not to damage the surface of the cable lug or abrade the contact surface with the screwdriver.

The heat-shrinkable tube must have no signs of damage after the repair otherwise leaktightness might not be guaranteed.

The cable lug and the heat-shrinkable tube may be replaced if necessary.

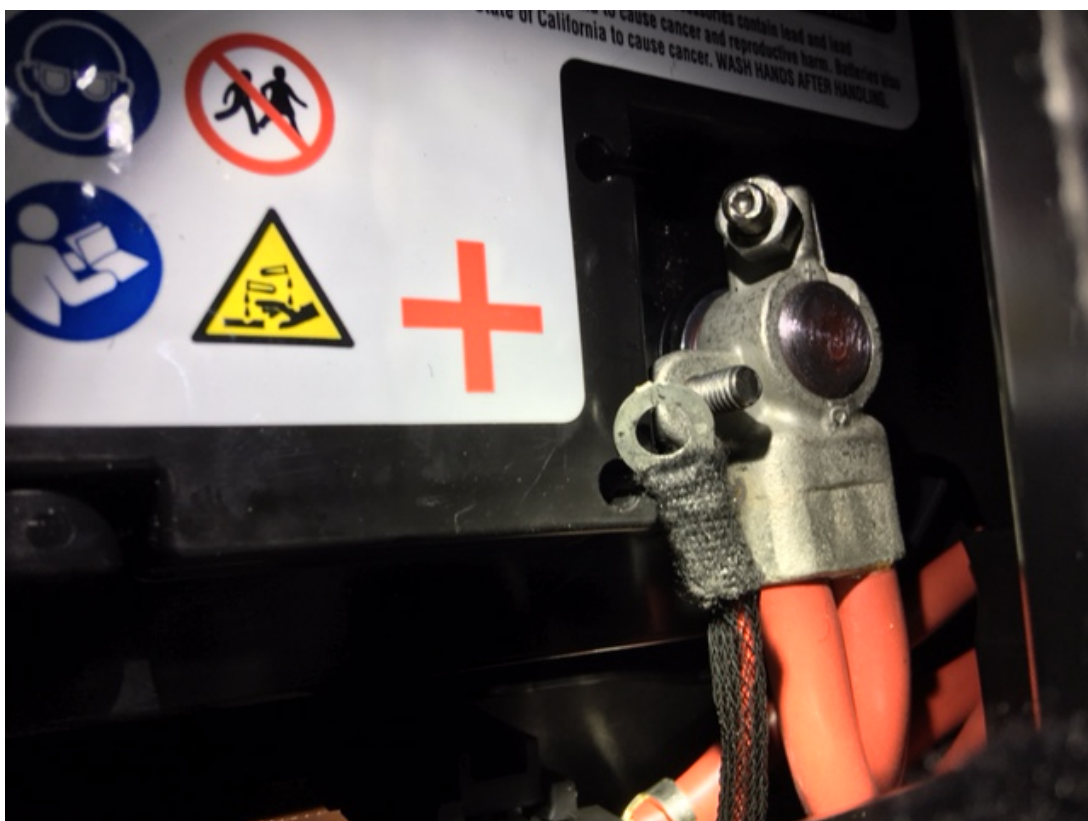
Tape on pos term wire. JPG:

Excess fabric tape on the cable lug of the measurement line (0.75 mm<sup>2</sup>) from the on-board electrical system battery G1 to the battery sensor B95 leads to an increase in the internal resistance R<sub>di</sub> of the battery. Due to the high battery internal resistance, the yellow fault message is generated in the multifunction display at 8 mΩ and above.

Carefully remove (detach) the excess fabric tape by hand until the contact surface of the cable lug is free of fabric tape (residues). Then snip off (remove) the excess fabric tape using side cutting pliers.
