## Yellow battery symbol fault message in multifunction display "Start Engine. See Owner's Manual".

Topic number	LI54.10-P-067414
Version	1
Function group	54.10 Battery, power supply, voltage converter
Date	12-04-2017
Validity	Model 205, 253 Model 166, 292
Reason for change	
Reason for block

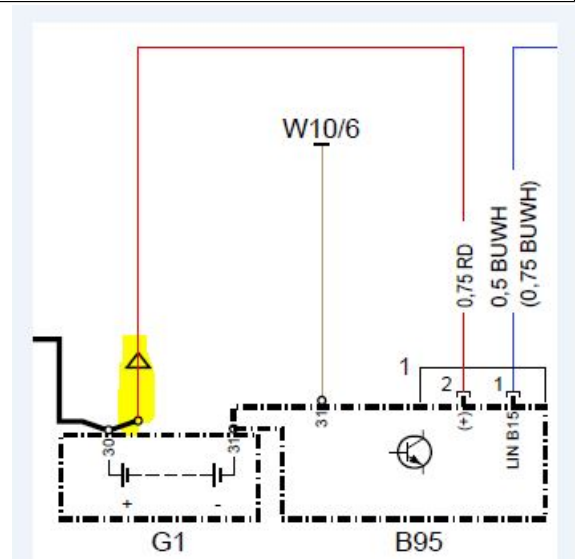
Schaltplan.JPG:

Excess hot melt adhesive from the heat-shrinkable tube on the cable lug of the measurement line (0.75 mm<sup>2</sup>) from the on-board electrical system battery G1 to the battery sensor B95 leads to an increase in the internal resistance R<sub>di</sub> of the battery. Due to the high battery internal resistance, the yellow fault message is generated in the multifunction display at 8 mΩ and above.

Excess fabric tape on the cable lug of the measurement line (0.75 mm<sup>2</sup>) from the on-board electrical system battery G1 to the battery sensor B95 leads to an increase in the internal resistance R<sub>di</sub> of the battery. Due to the high battery internal resistance, the yellow fault message is generated in the multifunction display at 8 mΩ and above.
